**Humisphere**

**SOIL RECONNAISSANCE MISSION TO 3 ESTATES IN TANZANIA**

**September 2012**

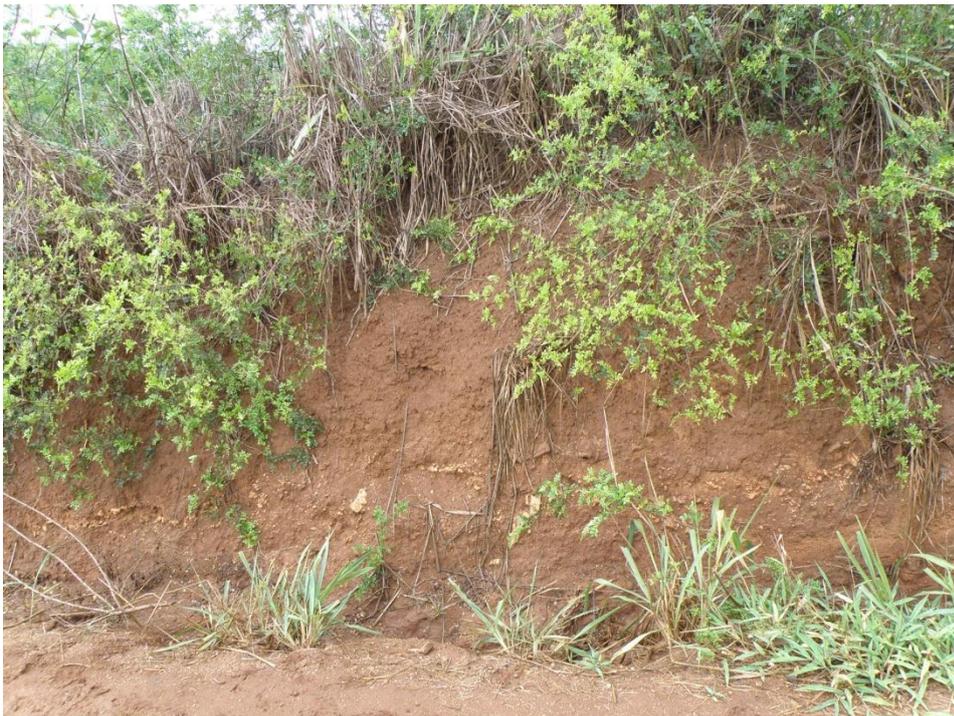
Deep red soils have been observed in road cuttings and in auger hole observations. These soils are similar to those of Kwamdulu estate.

Deep red soils in Kwaruguru estate.

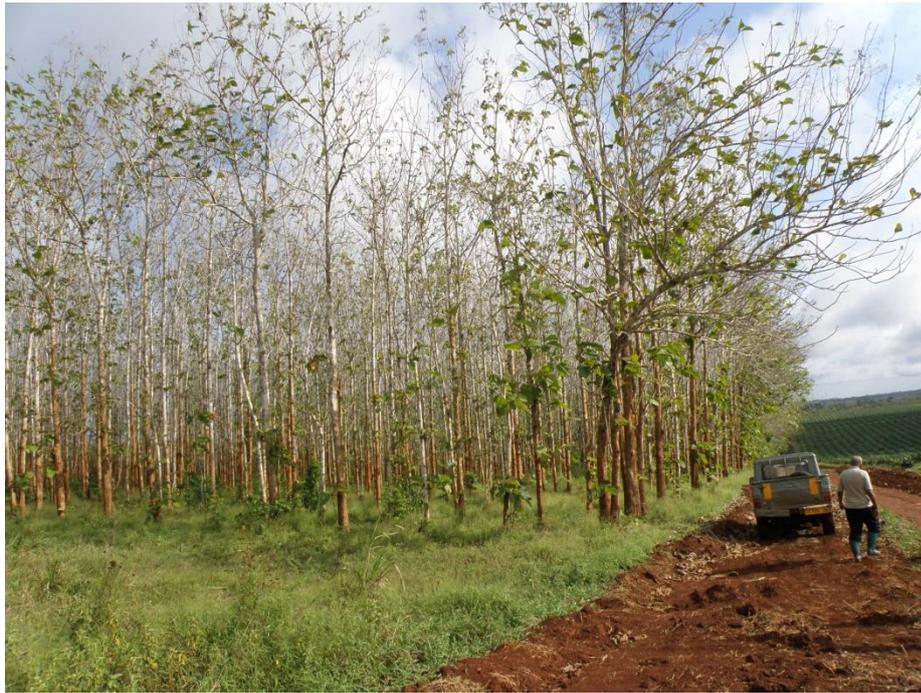
In Kwaruguru estate a pilot teak plantation is situated on a slope of 7 to 8%. Here two soil augerings have been made, one just above the plantation (augering 1) and one just down slope the plantation (augering 2). Both augerings showed uniform deep red soils more than 150 cm deep, without any obstruction to roots, which are representative for the suitable areas of the estate. The teak plantation showed a reasonable growth of the trees: the growth of teak is 15 m<sup>3</sup>/ha year (source: FORM International) .

Teak plantation in Kwaruguru estate.
